Exhibit O

Comparison of the *In Vivo* Behavior of Polyvinylidene Fluoride and Polypropylene Sutures Used in Vascular Surgery

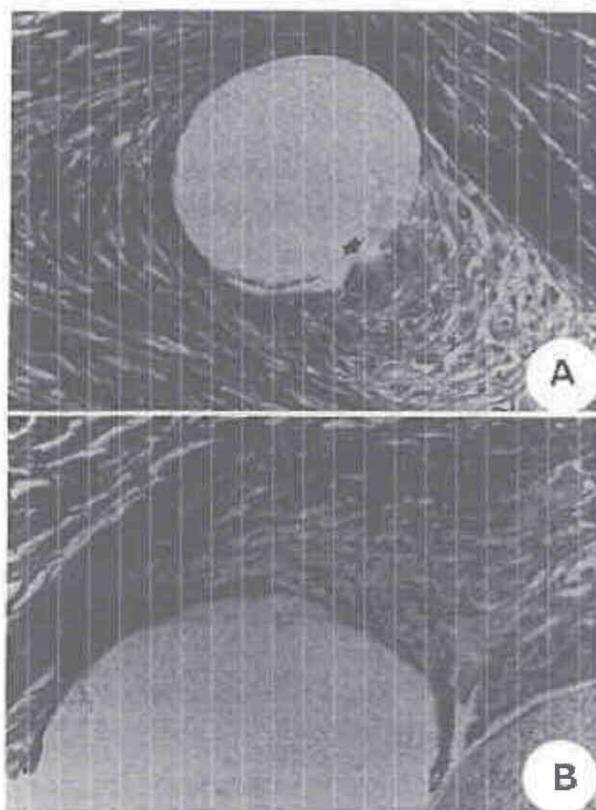
Figure 2. Light photomicrographs of polyvinylidene fluoride sutures at the distal anastomotic site after 1 and 3 months of implantation. At 1 month, the suture is surrounded by fibroblast-like cells, collagen deposits, and a few macrophages (arrow) (A, $\times 500$). After 3 months, the presence of inflammatory cells around the sutures (B) was rarely observed (B, $\times 500$).

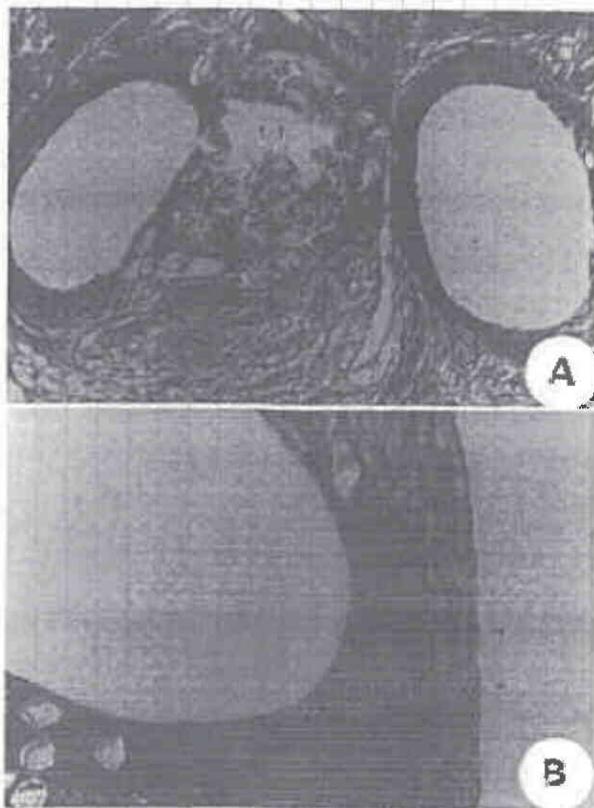
Figure 3. Light photomicrographs of polyvinylidene fluoride sutures explanted at 6 months. The sutures located adjacent to the prosthesis were subjected to a chronic inflammatory response directed toward the polyester fibers (arrows). Nevertheless, they were covered by a thin lining of collagenous tissue (A, $\times 250$). Near the luminal surface, the suture was encapsulated by the newly formed internal collagenous capsule without any inflammatory cells. Endothelial-like cells can be observed covering the collagen tissue (arrows) (B, $\times 500$).

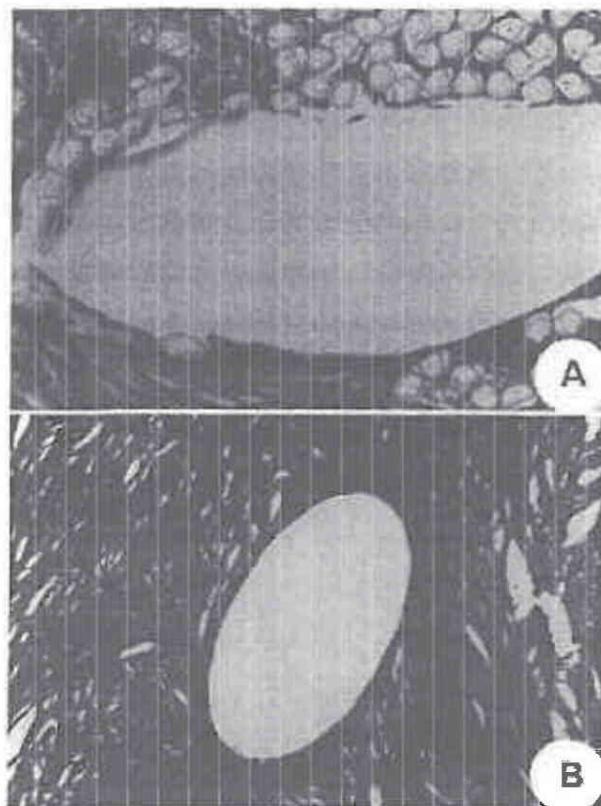
Figure 4. Light photomicrographs of polyvinylidene fluoride sutures after implantation for 1 and 2 years. At 1 year, the suture located in the graft wall was encapsulated by collagen infiltrating the polyester skeleton without evidence of an inflammatory reaction (A, $\times 500$). Sutures examined after 2 years also revealed complete encapsulation by collagenous tissue without the presence of inflammatory cells (B, $\times 500$).

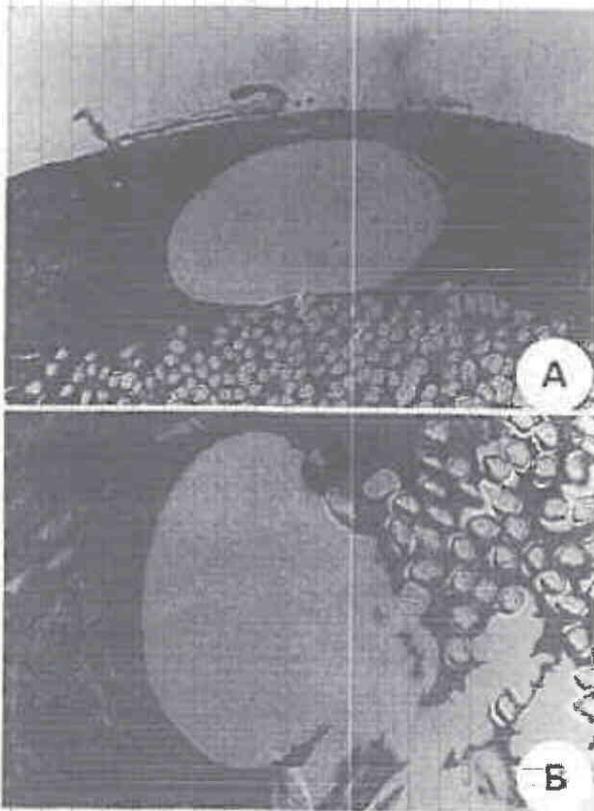
Figure 5. Light photomicrographs of polypropylene sutures retrieved from the anastomotic sites of vascular grafts after 3 and 6 months implantation. After 6 months, the sutures located in the collagenous tissue covering the luminal surface of the graft do not exhibit any inflammatory response (A, $\times 250$). The sutures present in the polyester grafts are surrounded by fibroblast-like cells and collagenous tissue without the infiltration of inflammatory cells (B, $\times 500$).

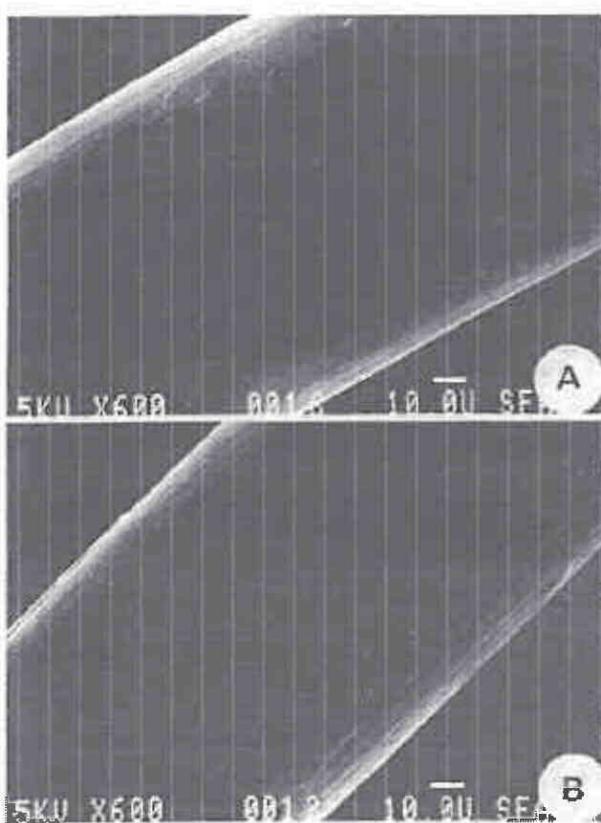
Figure 6. Scanning electron photomicrographs of retrieved and cleaned 6-0 polyvinylidene fluoride sutures showing the surface morphology after implantation for 1 (A, $\times 600$) and 2 (B, $\times 600$) years *in vivo*.

The reason why this cracking phenomenon was not observed with the explanted PVDF sutures after 1 year and 2 years *in vivo* is not known at this time. One possible explanation for the apparent superior biostability of the PVDF monofilaments, however, may lie in their less pronounced bicomponent skin/core structure, which is attributable to their different manufacturing history.¹⁷

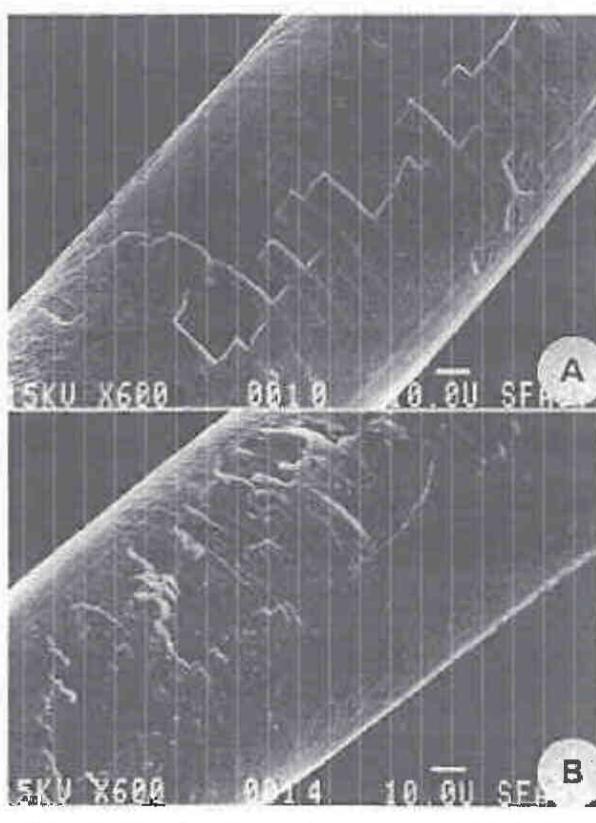
were well preserved, without any evidence of surface pitting or cracking. Evidence of iatrogenic trauma was occasionally observed, however, with both types of sutures. This phenomenon is inevitable, and results from the manipulation of the monofilaments with the tweezers or needle holder during the anastomotic procedure. After 1 and 2 years of implantation, the surface of the retrieved and cleaned PVDF sutures did not appear to be substantially modified (Figure 6). In contrast, the polypropylene sutures explanted 1 and 2 years postoperatively showed evidence of surface deterioration, characterized by uniformly spaced circumferential cracking and peeling and flaking of the polymer material in the outermost surface layer (Figure 7).

Figure 7. Scanning electron photomicrographs of retrieved and cleaned 6-0 polypropylene sutures showing the surface morphology after implantation for 1 (A, $\times 100$) and 2 (B, $\times 600$) years *in vivo*.

The reason for this stress cracking phenomenon in oriented polypropylene monofilaments has been explained by their pronounced skin/core structure. This bicomponent structure is created by the differential cooling rates between the external and internal layers of the monofilaments during the melt spinning process, which leads to the formation of a low order nonfibrillar outer skin a few microns thick, and a highly oriented crystalline fibrillar inner core.³³ Blais *et al.* identified a distinct separation and different properties between these two layers. They found that the outer skin is more susceptible to oxidative degradation than the fibrillar inner core. Cleavage of the polymer chains causes relaxation of the folded lamellae, increases in crystallinity and density, and contraction localized to the outer skin. This in turn leads to regular circumferential crack formation at the surface, but only to the depth of the outer layer.³³ Because this cracking is confined to the outer skin, which is clearly distinguishable from the inner core structure, it is not surprising to observe that, during abrasive stresses, such as cleaning, there was a tendency for the cracked rings at the surface to flake off and separate from the underlying core material (Figure 7).

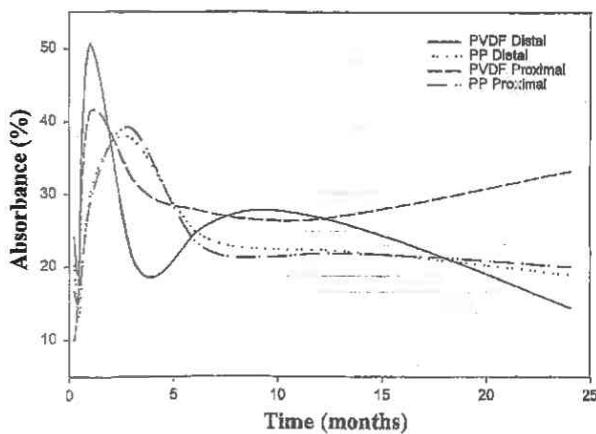
which has been assigned to the carbonyl group and gives information about the extent of surface oxidation. The results for the two materials have been plotted vs the implantation time in **Figure 8**.

It is noteworthy that all four curves have some similar characteristics. The PVDF and polypropylene sutures experienced an early increase in carbonyl absorbance soon after implantation, which reached a maximum value within the first 1–3 months. After this time, it decreased to an average value, where it remained approximately constant for at least 1 year postoperatively. The timing of the peak seems to differ for the two types of suture—at 1 month for PVDF and 3 months for polypropylene (**Figure 8**). This period corresponds to the formation of a continuous collagenous capsule around the sutures (**Tables 1, 2**), and the difference in timing may be explained by localized differences in the rates of healing between the two types of suture.

Figure 8. Carbonyl absorbance of polyvinylidene fluoride and polypropylene sutures after different implantation times.
